SAUL RUN DAM

NDI No. PA 00251  
PennDER No. 43-48

PHASE I INSPECTION REPORT  
NATIONAL DAM INSPECTION PROGRAM

Saul Run Dam, Mercer County, Pennsylvania  
NDI NO. PA 00251, PennDER NO. 43-48  
Saul Run  
Date Inspected 7 December 1978

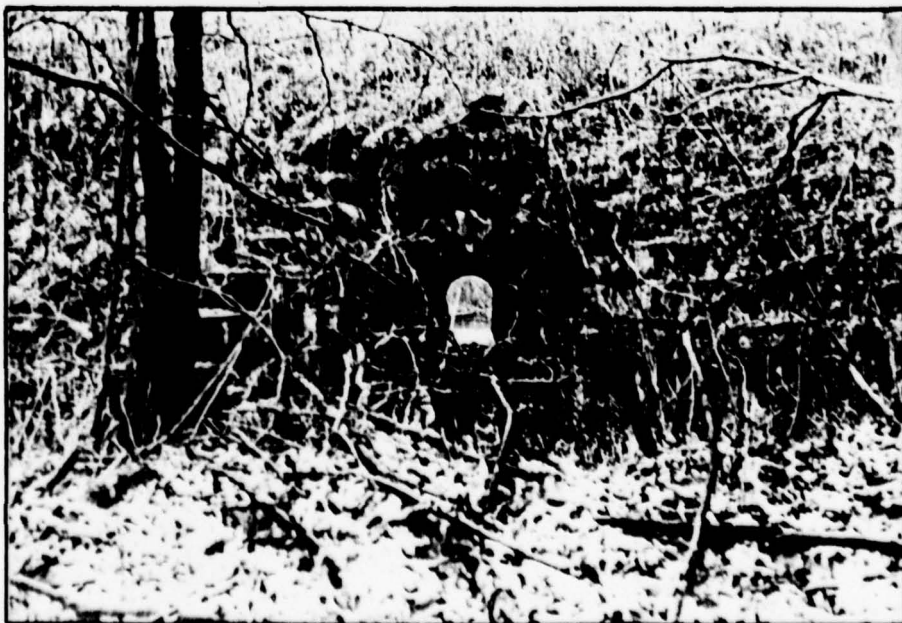
VISUAL EXAMINATION OF		OBSERVATIONS	REMARKS OR RECOMMENDATIONS
CONDITION (OBSTRUCTIONS, DEBRIS, ETC.)	The downstream channel is relatively free of debris and obstructions. The overbank areas are primarily wooded. There is a 10-ft. high by 7 to 8 ft. wide stone-masonry, arch railroad culvert approximately 300 ft. downstream from the dam. This culvert could cause a serious obstruction to flow if it were blocked with debris. The top of the railroad embankment is approximately 40 ft. above the culvert invert.		
	SLOPES	Left bank slope has glacial till over weathered sandy shale-shaly sandstone bedrock. Right bank slope is glacial moraine or ice contact ridge (probably a kame-type deposit). The gorge-like channel was probably cut by glacial meltwater and runoff.	Downstream channel slopes to railroad embankment arch culvert are stable from soil mechanics and hydraulics (erosion) standpoints.

**PHOTO 6. Stone Arch Culvert beneath Railroad**

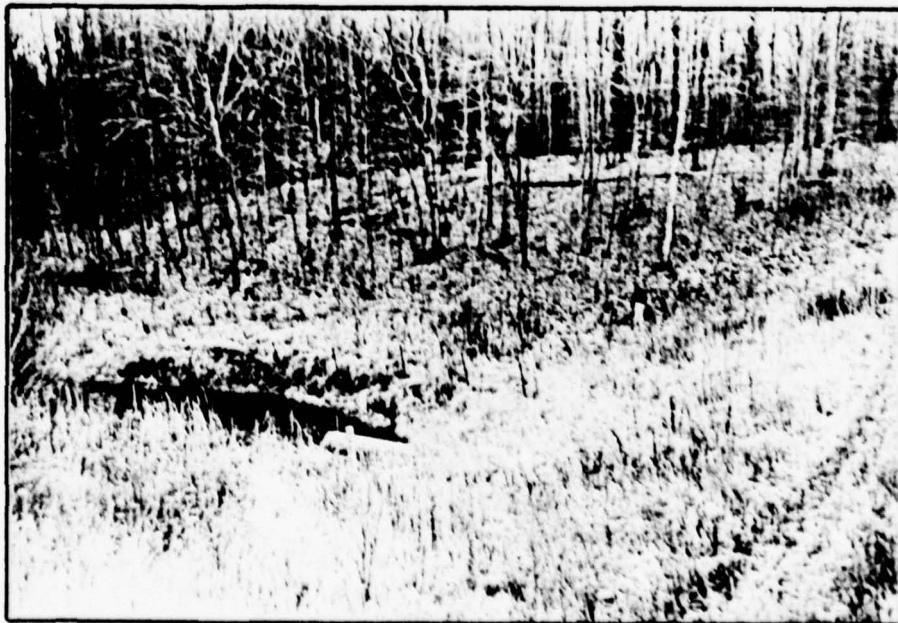
Seepage estimated at about 1 g.p.m. was noted about 8 feet above tailwater (about 5 feet above dam toe) at the junctions of the downstream slope with both abutments in the Saul Run channel. No evidence of piping (internal erosion of fine soil particles) was observed at these locations.

Minor to moderate seepage on the order of a few g.p.m. was also noted along both sides of the Saul Run channel for distances of 80 to 100 feet downstream from the toe of the dam. Maximum heights of seepage were about 8 and 12 feet above tailwater on the right (east) and left (west) sides of the channel, respectively. No evidence of piping was observed at these locations. Soft, wet, swampy areas exist along both stream banks beneath these areas of seepage from the downstream channel sides.

**PHOTO 10. View East at Downstream Right Abutment**

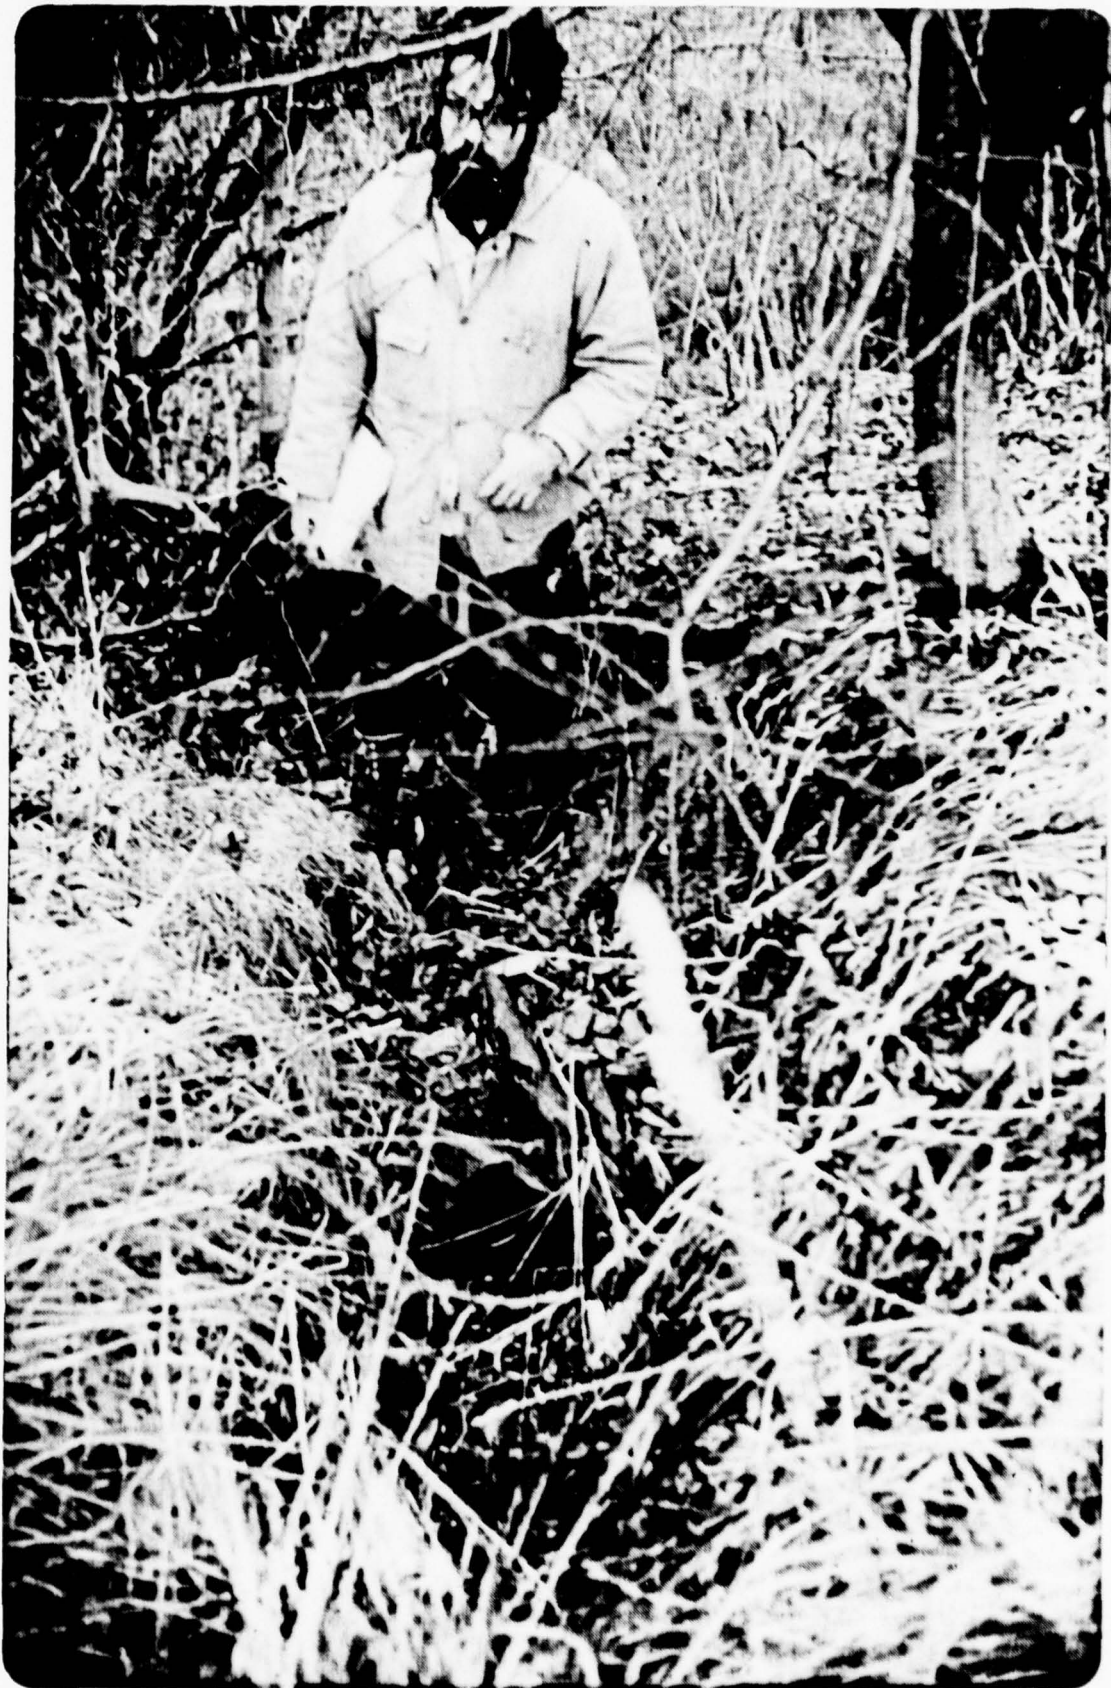
Three small erosion gullies (the largest about 20 feet long with maximum width and depth of about 3 feet) were noted at the center of the downstream end of the spillway where surface runoff flows down the natural slope to Saul Run. These erosion gullies should be repaired during routine maintenance in 1979. Properly bedded riprap or other measures should be installed in this area to prevent erosion from surface runoff.

**PHOTO 11. Close-up of Largest Spillway Outlet Erosion Gully**
